# **Evaluation Report**

628

Vicon MP800 Baler

#### **VICON MP800 BALER**

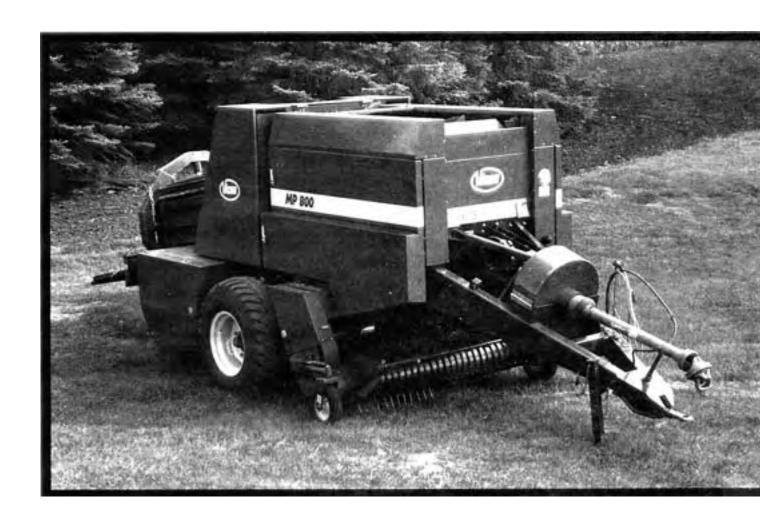
**FIGURE 1.** Vicon MP800 Baler: (1) Power Take-off Shaft, (2) Packer Fingers, (3) Pickup, (4) Auger, (5) Twine Needles, (6) Hydraulic Density Control Cylinders, (7) Knotters, (8) Plunger.
